The Seagate ST-251 Hard Drive Stiction Revisited

This article documents what I had found during my troubleshooting of these ST-251 40Mb hard drives. I took a different tact though. This time, I dug around at the circuit level in an effort to determine if the drive or the controller board (PROM) was causing the problem.

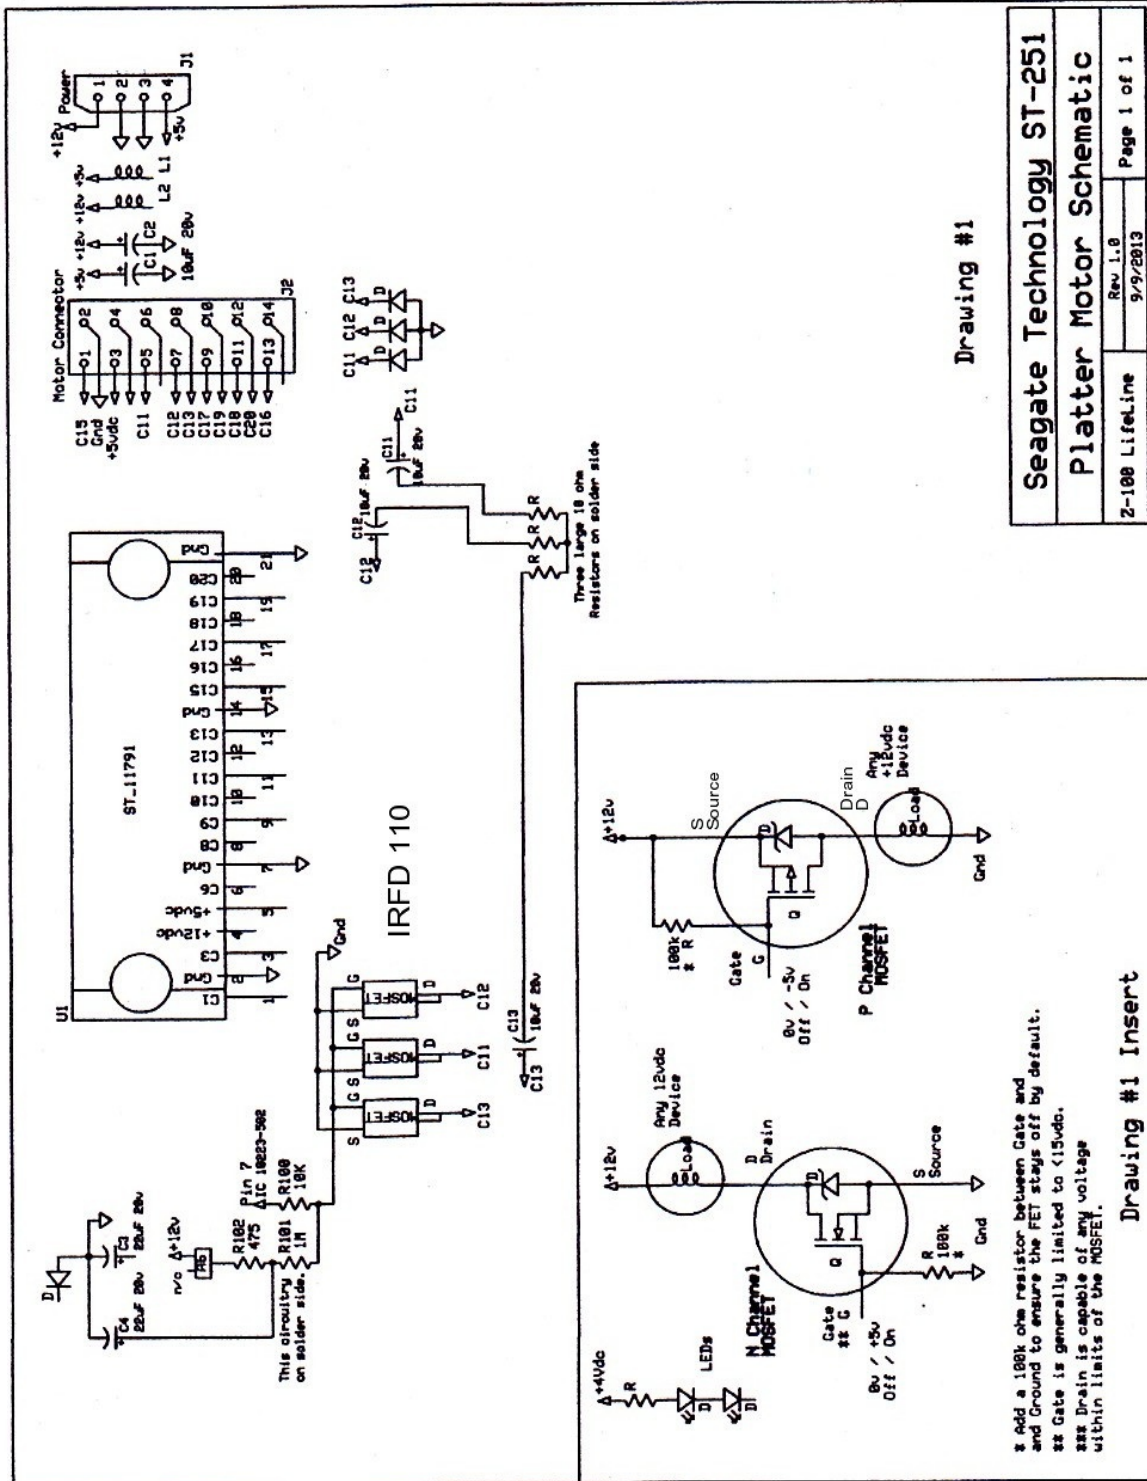
Drawing #1

Finally, I did some DC voltage checks. These were taken at various points in the circuit of Drawing 1 and measured from board ground. The voltages on the drawing are those of a working drive. But, as we are mostly interested in the motor connector, I will list them separately here.

On those boards that do not spin the drive, pins 3, 4, 11, & 13 measure about .6 volts!

The drain voltages would be 0.55-0.72v on the non-working boards.

Circ/ Pin#:	Non- Spin:	Circ/ Spin:	Non- Pin#:	Spin:	Spin:
C1	1.2v	1.25v	C11	7.8v	<4v
C2	Gnd	Gnd	C12	7.8v	<4v
C3	3.6v	0	C13	7.8v	<4v
C4	+12vdc	+12vdc	C14	Gnd	Gnd
C5	+5vdc	+5vdc	C15	2.5v	2.5v
C6	1.8v	1.8v	C16	2.5v	2.5v
C7	Gnd	Gnd	C17	2.5v	2.5v
C8	3.8v	0.2v	C18	2.5v	2.5v
C9	1.0v	0.2v	C19	2.5v	2.5v
C10	12.5v	12.5v	C20	2.5v	2.5v
			C21	Gnd	Gnd

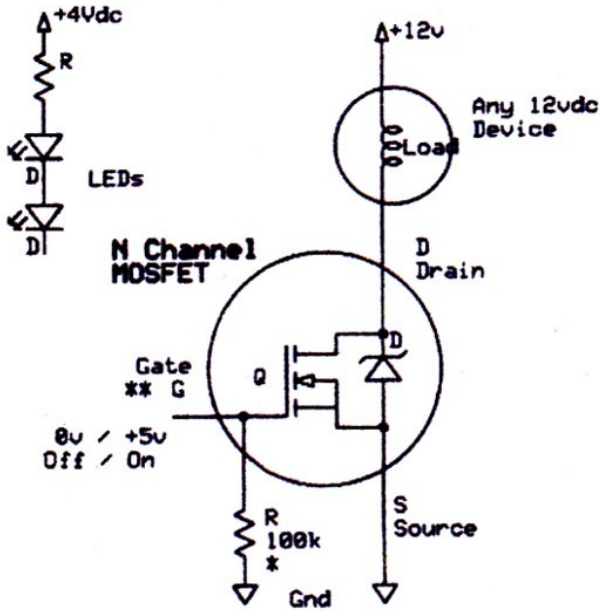
Drawing #2

As you can see from the drawing, the N channel MOSFET acts like a relay, controlling the ON/OFF of a different (not necessarily higher) voltage load using low voltage control. The MOSFET can be either N-channel or P-channel and uses three leads, the Drain, the Source, and the Gate. As we are using the N-channel version, the following description will concentrate on that. However, for comparison purposes, the P-channel version is shown in Drawing #3.

According to these specifications, the load device attached to our IRFD110 MOSFET could be rated for anything up to 100 volts, if needed. The Gate turns the MOSFET ON at +5vdc. Also, note that a 100k ohm resistor is recommended to ensure that when the circuit controlling the Gate is OFF, the 100k ohm resistor bleeds the voltage to zero, ensuring that the Gate is OFF.

Back to reality, our circuit is not nearly this simple. However, armed with this information, we can see that if the MOSFET is left ON when power is removed, the MOSFET internal resistance can appear to be nearly zero - both ways. Through experimentation, I found that the motor will indeed still spin properly with these MOSFET's seemingly shorted.

In addition, on the boards that do permit the drives to spin, I found that the drives will still spin with the MOSFET's completely removed! Our non-spin problem must be elsewhere.

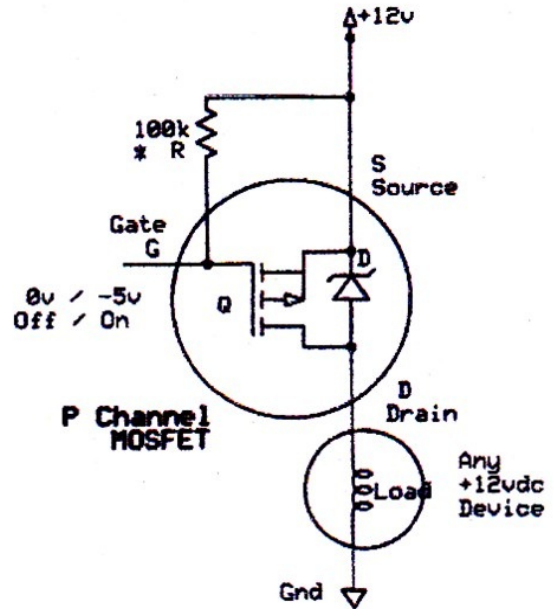
Drawing #3

Note: The P-channel MOSFET uses 0v and -5vdc at the Gate to turn OFF and ON respectively. The resistor in this case is tied to the +12v supply to ensure the Gate is OFF and at a positive voltage, thus ensuring the MOSFET is OFF.
