This article was first published in issue #42, December 1995

## Z-100 Field Service Bulletins

by Steven W. Vagts  
Editor, "Z-100 LifeLine"

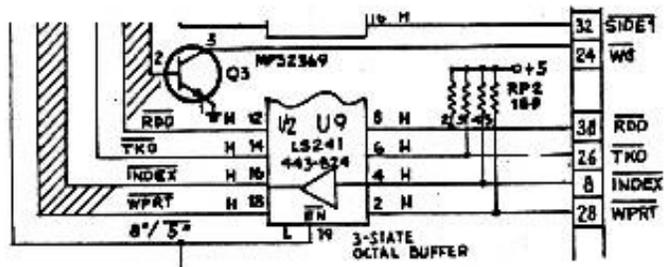
Locate the lower portion of U9 (near the 5" interface connector) and change the buffer symbol as follows:

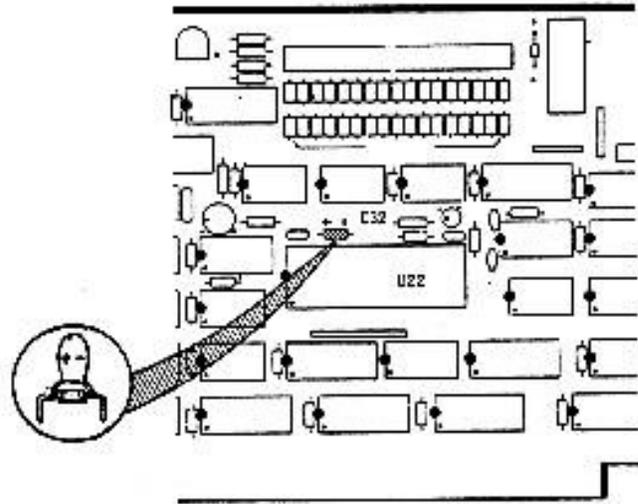
Connect a 10 uF capacitor in parallel with the 0.1 uF capacitor at C32. Be sure the positive and negative leads of the 10 uF capacitor are positioned to the left of the component side of the board (with the 100-pin connector down).

This update was performed only "as needed." (*I don't know about earlier boards, but the 85-2807-2 and -3 boards already have both capacitors installed, as C32 and C32-1. Check earlier boards, the -1 board also may have it installed - ed.*)

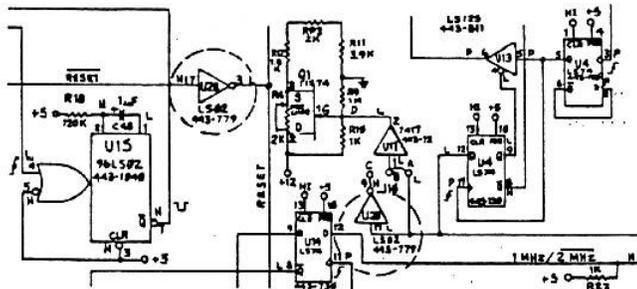
Figure 026.

Locate the two inverter sections labeled "U28" beside "U15" and "U14" on your schematic (see figure 026) and change to "U10."

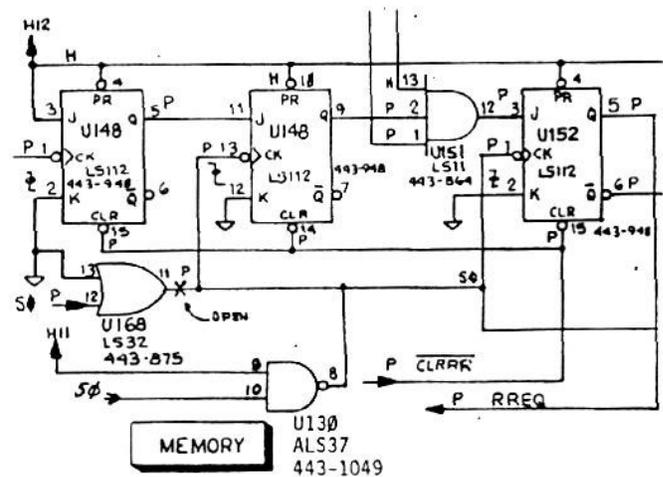
On newer versions of the Z-100 main board, HE 181-4106, 181-4507, 181-4920, 181-5743, and higher, a section of U130 (443-1049) is inserted into the Refresh Timing and Arbitration circuit. This section of U130 replaces a section of U168 used on the old main boards (HE 181-3630). To update your MB3 schematics, refer to the pictorial below and draw in the section of U130.
