A Professional Journal Exclusively for the Heath/Zenith Z-100 Computer

The Z-207 Controller That Could Not Control!!

The Memory Card That Could Not Remember!

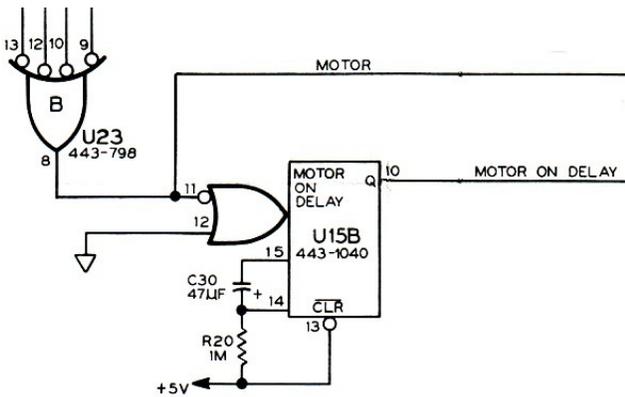
While this Z-207 controller, marked "85-2807-2 & 072883", was correctly silk screened, it had the factory installed C30, 47uF 6v tantalum capacitor installed reversed. I had another, similarly numbered controller, but the capacitor was installed correctly, so I thought it must have been a fluke.

The C30, 47uF capacitor is a timing capacitor for U15B, a 96LS02 (Heath part #443-1040) multi-vibrator that provides a Motor-on Delay. As you may recall, this delay was meant to keep the motor running for only about 15 seconds after the last disk access, then the motor was meant to stop when the capacitor was discharged.

If you look at the schematic of U15B, you can see that C30 gets its power through R20, a 1 Megohm resistor to the +5Vdc power supply. However, you may also note that the capacitor symbol is upside down, the curved part should be negative, flat side to positive, but we are being picky.

Anyway, I reversed the C30 capacitor, per the schematic. In the past, there have been several complaints that the floppy drive would run forever (See LifeLine issue #62). This trouble was found to be a leaky, but not shorted nor open C30. It also occurs if the capacitor is installed reversed!

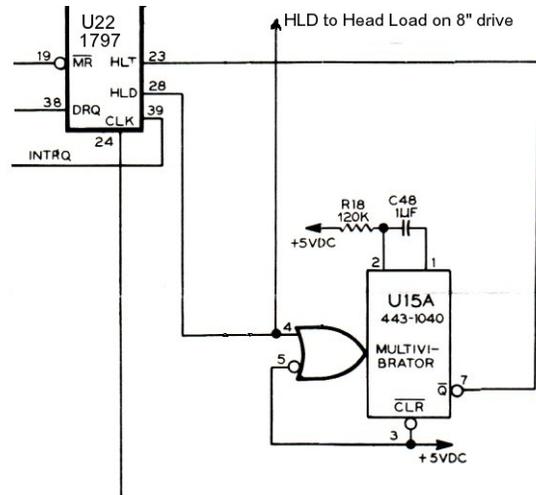
During the visual inspection I also found that R18 was a precision 150K ohm resistor instead of the 120K ohms specified:

This resistor is in the timing circuit of U15A, a multi-vibrator which provides the Head Load Timing (HLT) signal to U22, the 1797 Floppy Controller, which controls the Head Load signal to the 8" drive connector. When the Head Load Timing signal is low, the drive head is not engaged.

I have found no reason for the R18 value change mentioned anywhere. But if you are using 8" drives, this may provide some help.

I also replaced this with the correct size, but neither 'fix' had any affect on my problem.

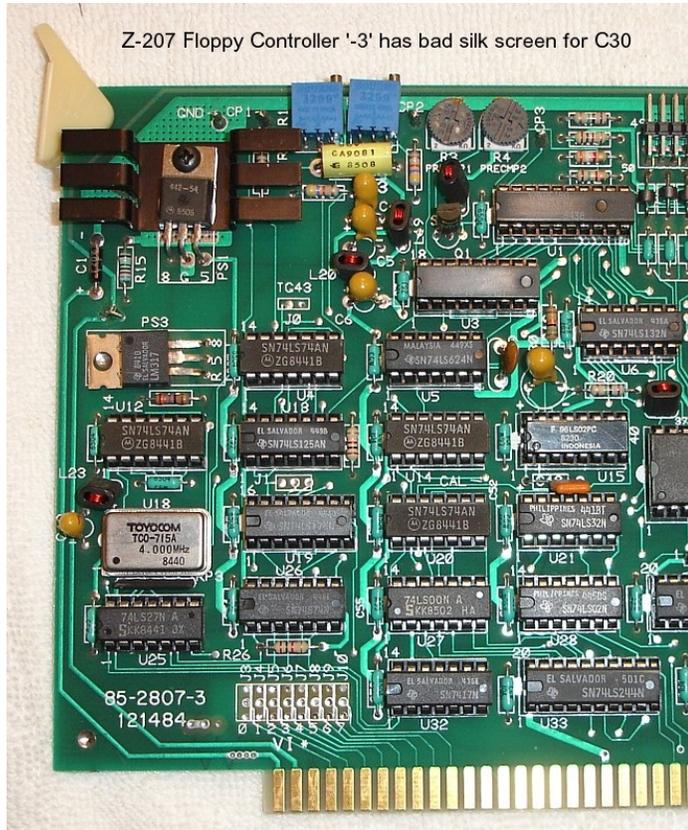
I have since found that a later Z-207 Floppy Controller board "85-2807-3" (also on the inop stack) that I had has the capacitor silk screen for C30 "+" on the left side instead of the

right side shown on the "-2" board. It also had a precision 150Kohm resistor as I had found on the "-2" board. So I guess that both of these 'mistakes' had been on purpose, but WRONG, at least for the C30 capacitor!

Z-207 Floppy Controller '-3' has bad silk screen for C30

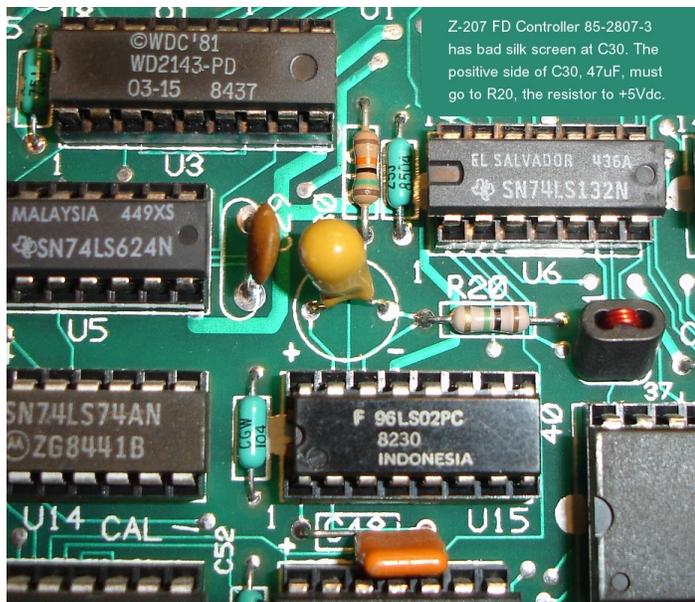
Z-207 FD Controller 85-2807-3 has bad silk screen at C30. The positive side of C30, 47uF, must go to R20, the resistor to +5Vdc.

You can clearly see the traces in the closeup. If you compare this with the circuit above, you can see that this is clearly wrong. Also, I checked the card's operation and the motor for the floppy drive never stopped! I reversed the capacitor and now the drive motor lasts about 18 seconds. Please note, and check your 85-2807-3 circuit boards!

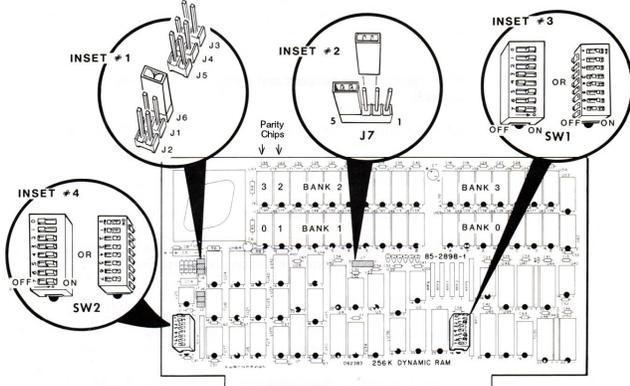
Typical Z-205 RAM Card Configuration

Note: Banks 0 and 1 are not correctly shown in the Zenith Z-205 User's Manual. Banks 0 and 1 were reversed. Bank 0, the 3000h memory block, is actually located in the lower right memory section, and Bank 1, the 4000h memory block, is actually located in the lower left memory sec-

tion. I have corrected this diagram in my User's Manual and added the location of the parity chips for additional clarification. I show the corrected figure here:
