## IDE NVsRAM Battery Replacement

by Charles Hett & Steven Vagts  
"Z-100 LifeLine" Staff

#### Z-100 BQ4850 NVsRAM Dead Battery Exploration by Charles Hett, Lenexa, KS, January 18, 2024.

**January 31, 2024, Rev. July 16, 2024**  
**By Charles Hett, Lenexa, KS**  
**NVSRAM BQ4850 2.0 Coin Cell Modification**

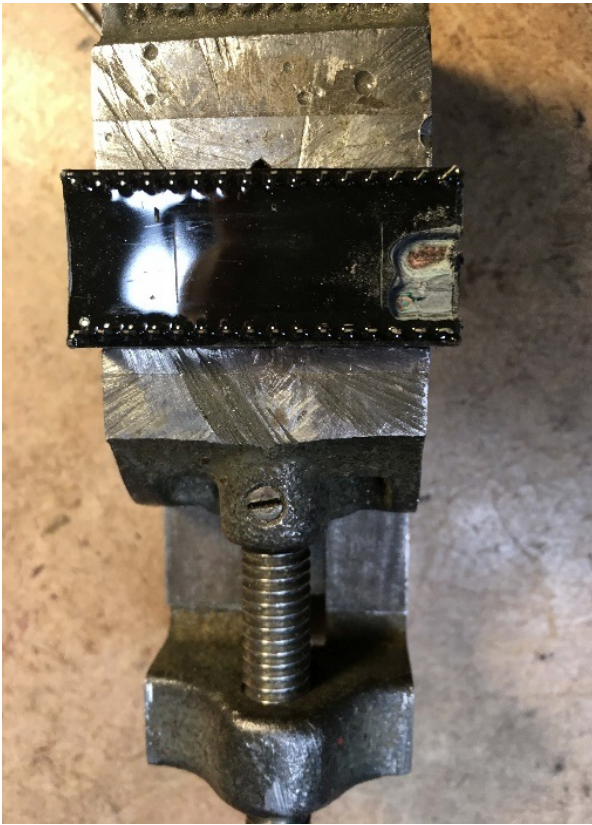
Photo 1. BQ4850 Bottom Exposure

I carefully plowed around the top of the device edges, but the area was found to be solid potting near the surface. I plowed the bottom near the ground pin 16. I hit some metal. A small round copper object and a small steel object were found. A little farther to the other side of the device a copper plane was found. The steel object and the copper plane had continuity to ground pin 16. I did not find anything that looked like a battery here. See Photo 1.

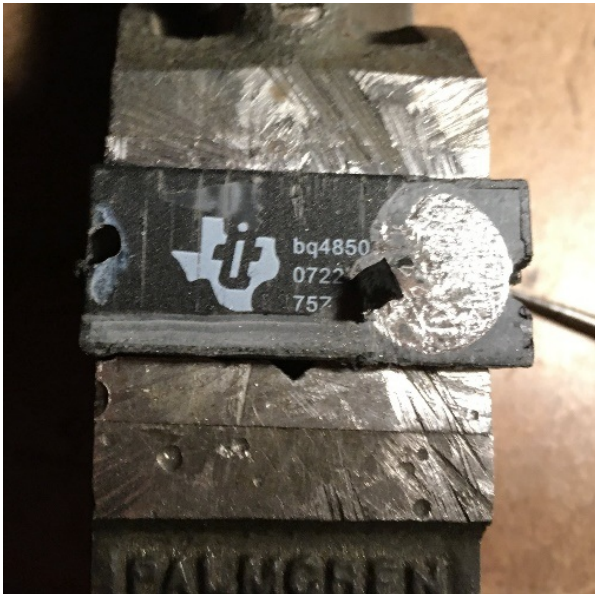
Photo 2. BQ4850 Top Exposure

I went back to the top near the ground pin end and eventually found the battery. (0.6" diameter - probably a CR16XX - I don't know the thickness). This large round area was not connected to ground pin 16 so I assumed this was the positive side of the battery. I found the tab inline between pins 10 and 11. See Photo 2.

I pried the tab loose from the case with a small scribe so that there was no continuity between the tab and the case, also shown in Photo 2.

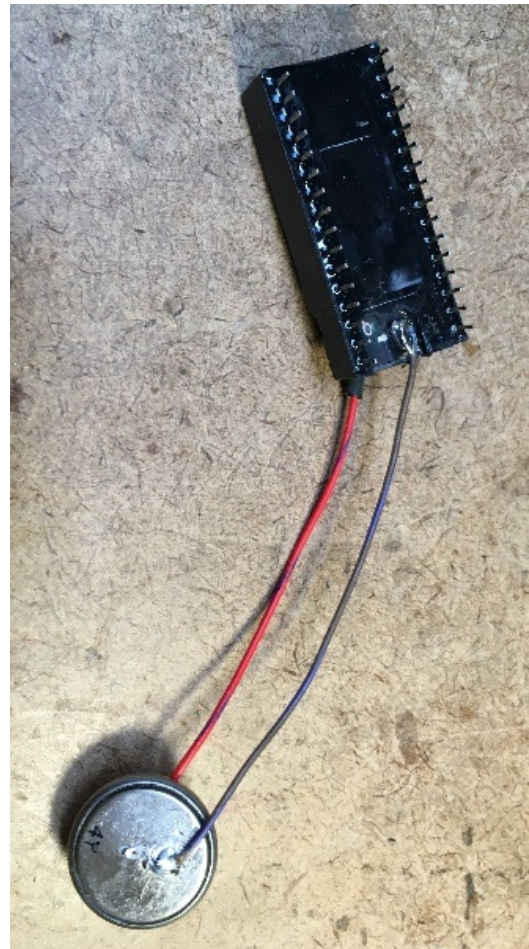
Photo 4. BQ4850 Negative Battery Connection

**Note:** The negative connection to the NVsRAM is not necessary, as the negative side of the battery just needs connection to the computer's ground plane.

I soldered a wire from the tab to the positive side of a CR2032 coin battery and a wire from the copper ground plane on the bottom to the negative side of the battery. See Photos 3 and 4.

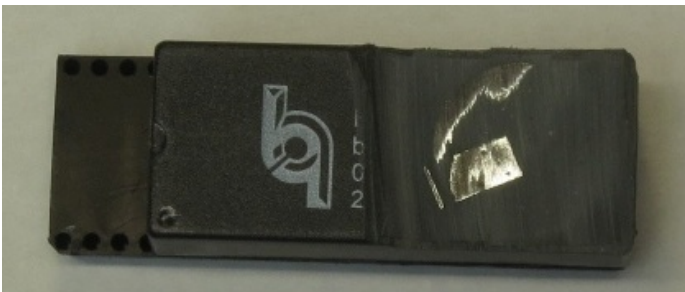
As you can see, I sanded a little too far and caused the tab fastened to the cell to separate from the unit. More on this later. The positive side of the battery is shown here. The coin cell measured 2.79 Vdc between this side and pin 16 of the NVsRAM unit.

I sanded off the right side of the top of the chip to gain access to the coin cell tab using the sanding disc attached to my wood lathe. I held the unit by hand while sanding.

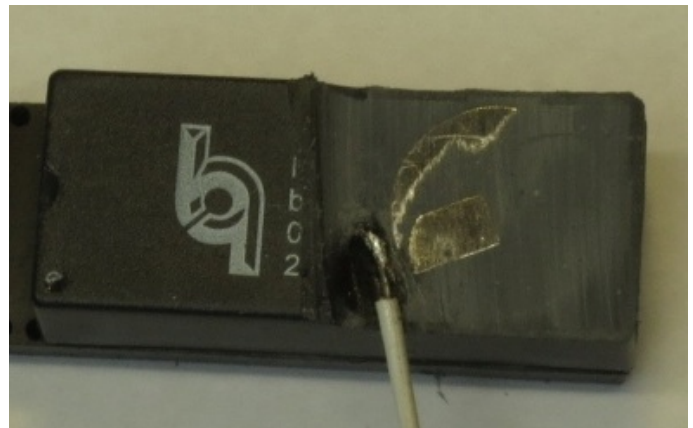
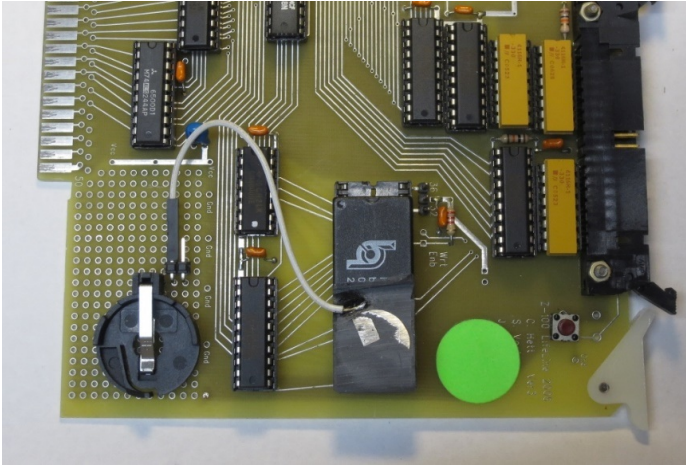
**Now for the bad news.** With the NVsRAM connected to the battery as shown, the RAM data is successfully saved with a power off/on cycle. However, the clock settings are still not retained on power up. Perhaps the modification somehow damaged the backup battery connection to the RTC circuitry. I had to heat the tab quite a bit to make the connection. The DOS clock settings are also lost if the Z100 is reset and rebooted without cycling power. Why would this be?

A 20mm (CR2032) size coin cell battery holder was installed in the lower right prototype area of an IDEHD board. The ground side was wired to ground on the IDE Controller board. The Positive side was wired to one of two right angle header pins. (The second is a spare. I was told once you needed an input, an output, and a spare for every system.)

The coin cell wiring is on the back side of the board and will need to be insulated as will the coin cell and holder on the top side. Depending upon the type of holder you are using, please ensure that the Positive side of the coin cell is ultimately wired to the tab on the NVsRAM.

Always check resistances around the new wiring before installing the new coin cell. **Note:** The green dot shown is not related to this subject.

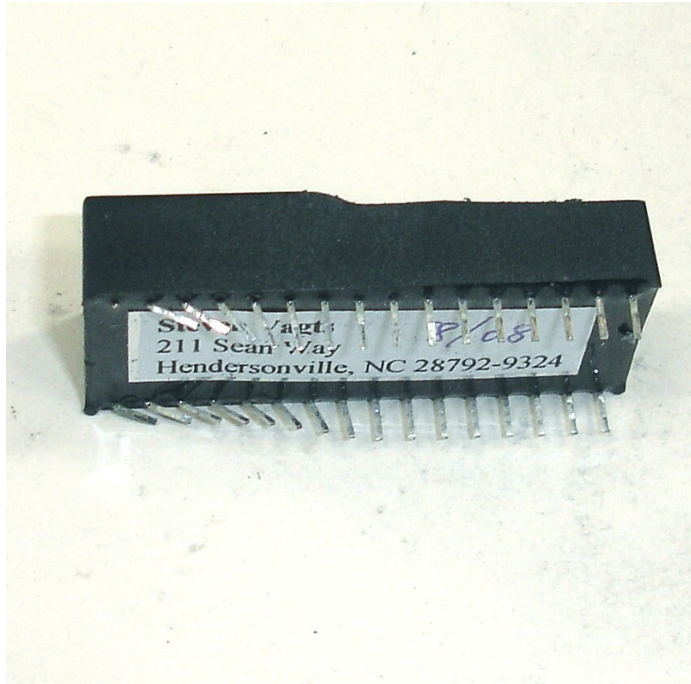
I decided to operate on the NVsRAM with the dead clock first, and I am glad that I did. I did not want to place the NVsRAM in a vise as Charles had done, feeling confident that I could take my time sanding off the top without squeezing it in a vise. Bad mistake! While trying to pry up the tab from the exposed battery, I exerted too much pressure on the unprotected pins and crushed them - and they would not straighten without breaking off!

Idiot!!

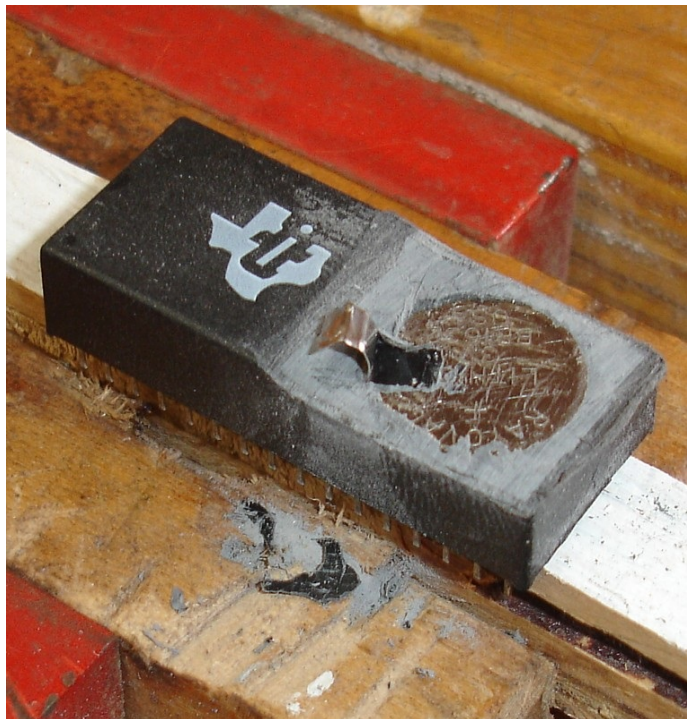
For the record, the battery cell was a Rayovac CR2032 coin cell. Between this positive battery side and pin 16 of the NVsRAM unit, it measured only 0.4Vdc on the first NVsRAM and 0.8Vdc on this one. Yet, we shall find that even this minimal voltage is critical to the NVsRAM's performance. I also measured the resistance from the tab to the ground pin, pin 16, on both NVsRAMs to be 0.675 ohms to ground. From ground to tab, the resistance was infinite.

Rather than continuing the sanding, and possibly damaging the battery case and/or tab, I found that a straight edge razor blade could easily slide between the metal of the battery and chip away the potting compound above it. In short order, I found the tab of the battery...

Once the tab was exposed, the razor blade can get under the tab far enough to grab the tab with a needle nose pliers and roll it back as shown.
