A Professional Journal Exclusively for the Heath/Zenith Z-100 Computer

Hard Drive Testing 1

The Hard Drive With a Split Personality 3

DIAG "Head Load Timing Error" on Z-207 Floppy Controller 7

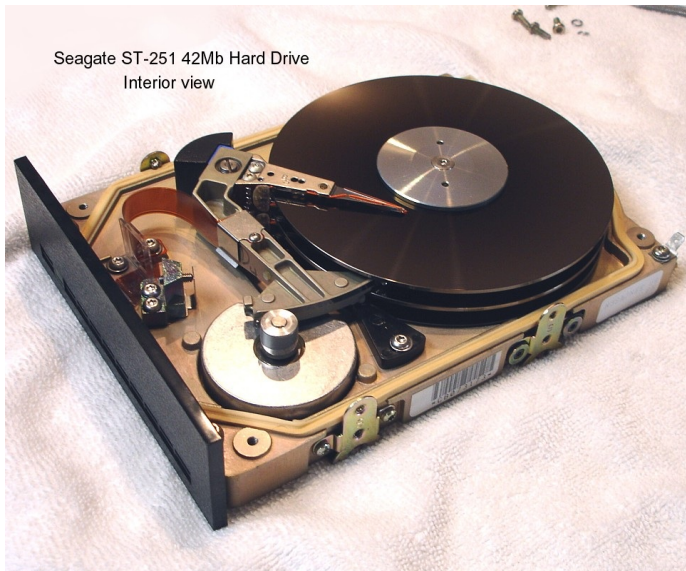
As you may recall, these were the subject of my several articles on STICTION over the years. And as luck would have it, I finally had one that was actually stuck. I had to remove the drive cover and rotate the platters to unfreeze it. The STICTION articles are also available on the website.

Note: When you remove the cover, you will see that the heads are mounted on the end of an arm that extends over the platter at an angle. Always rotate the platters in the direction that would extend the heads from their arms - that is counter clockwise in this case. If you rotate the other way, it may compress the heads into their arms and cause damage to the head as it twists. I have done it, and it turns the drive into a doorstop quite quickly.

I replaced the cover and completed the testing without further difficulty. If the drive is an earlier model, it may not have auto-park on shutdown. In addition to protecting the heads and platters against damage from dropping, use the SHIP utility for a drive with STICTION after every use, as the heads are moved towards the center of the spindle where the platter can exert more torque to break the heads' hold on the surfaces of the platters.

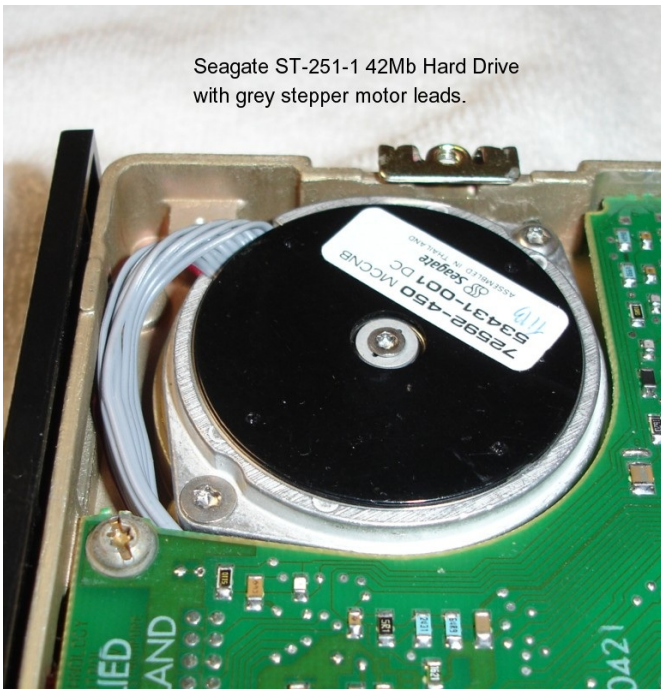
Seagate ST-251-1 42Mb Hard Drive with grey stepper motor leads.

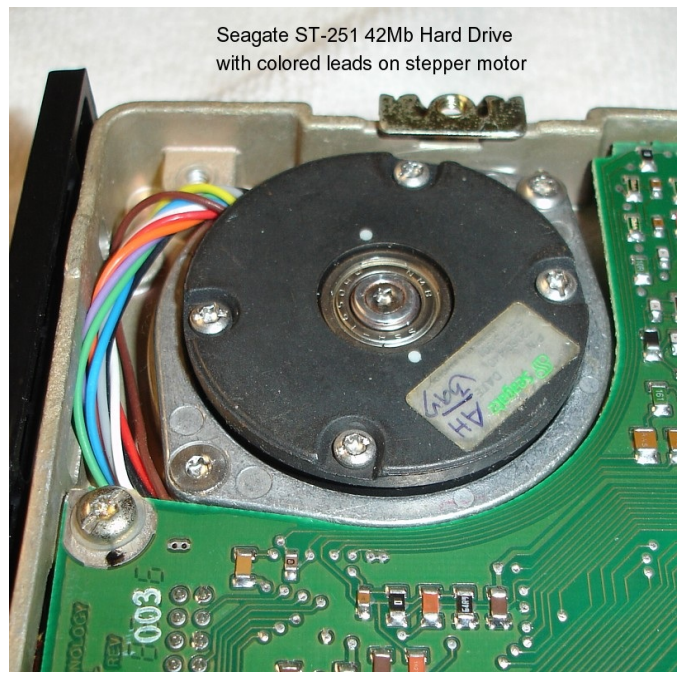
Seagate ST-251 42Mb Hard Drive with colored leads on stepper motor

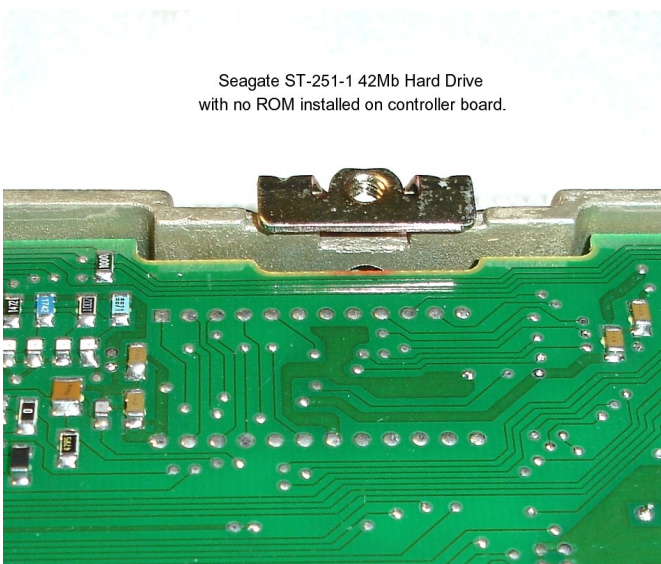
Seagate ST-251-1 42Mb Hard Drive with no ROM installed on controller board.

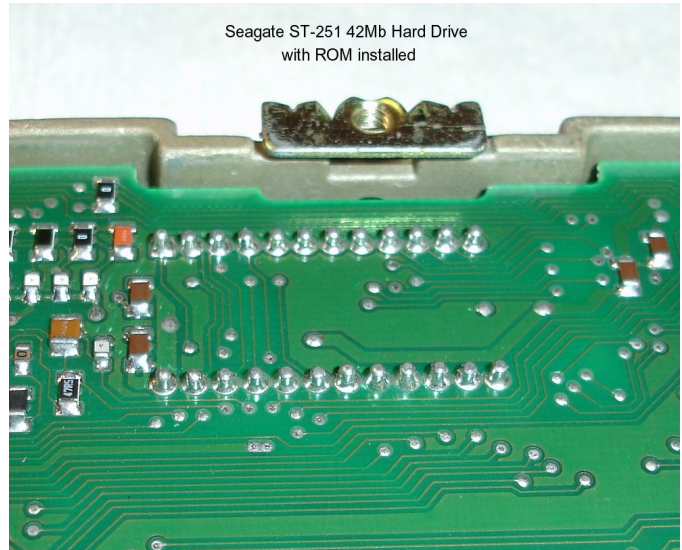
Seagate ST-251 42Mb Hard Drive with ROM installed

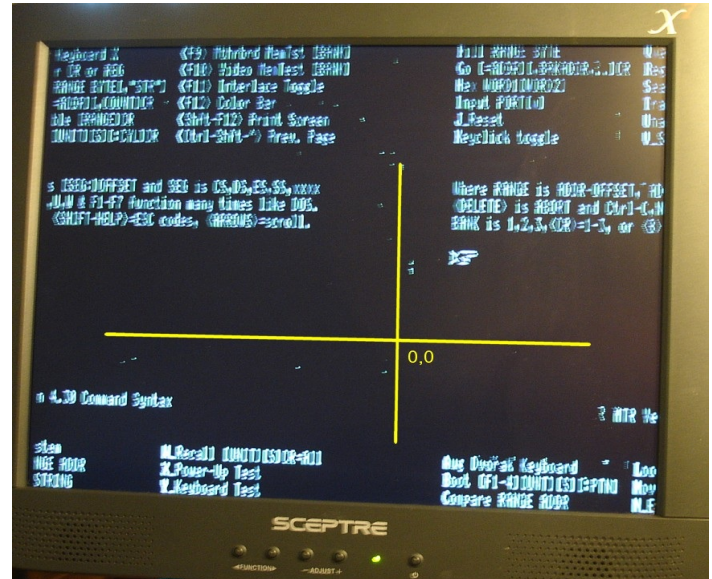
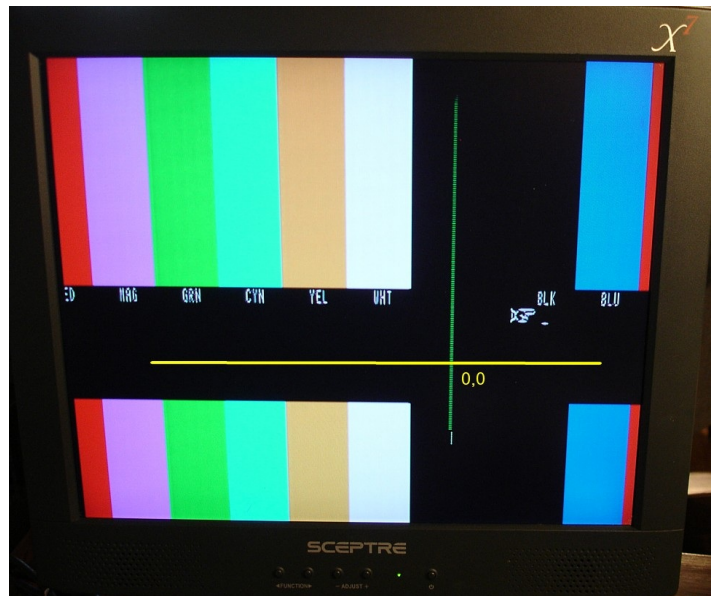
The video display suddenly broke into four quarters and froze. It would update every 30 to 60 seconds, redisplay the screen, with the four quarters split in a different location on the screen and freeze again.

I drew in the vertical and horizontal lines to make the effect easier to see, and, of course, the jitter was still there.

I pushed the menu button on the VGA adapter, located the 'Display' setting, and adjusted the V-position setting slightly higher.

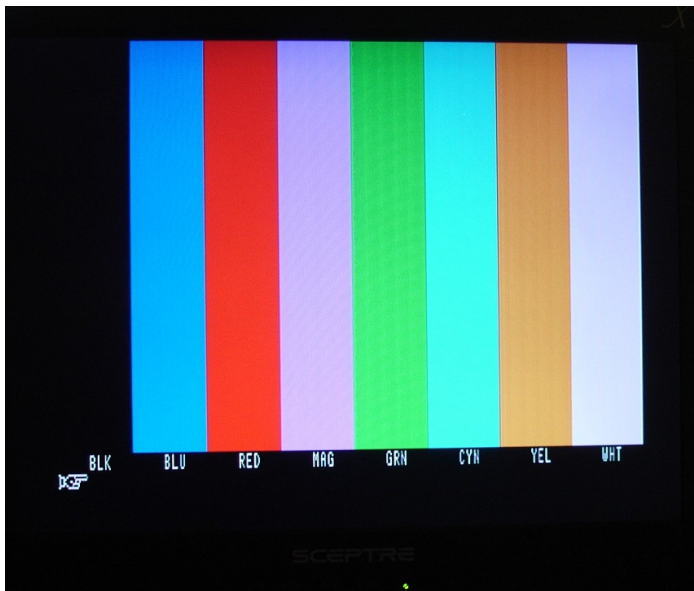
Sure enough, everything cleared up, no jitters, no odd video effects, no frozen video screen! A perfectly stable video screen with great colors...
