Remington RM1025SPS Chainsaw Repair

This article will focus on disassembly, repair, and reassembly. The repair will address the mechanical failure of the chain drive.

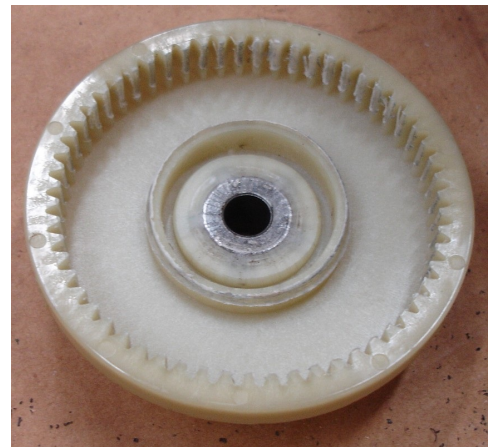
I am sorry that I don't have a picture of my melted bracket, but on my saw, the motor shaft was no longer held in position because the hole had been enlarged from an overheated motor shaft that became so hot as to melt the soft plastic that surrounded the motor bearing. This allowed the large gear to move towards the sprocket axle enough to disengage the teeth of the sprocket and grind down the teeth as shown in the next photo. If left unchecked, the teeth would eventually disappear, rendering the saw useless!

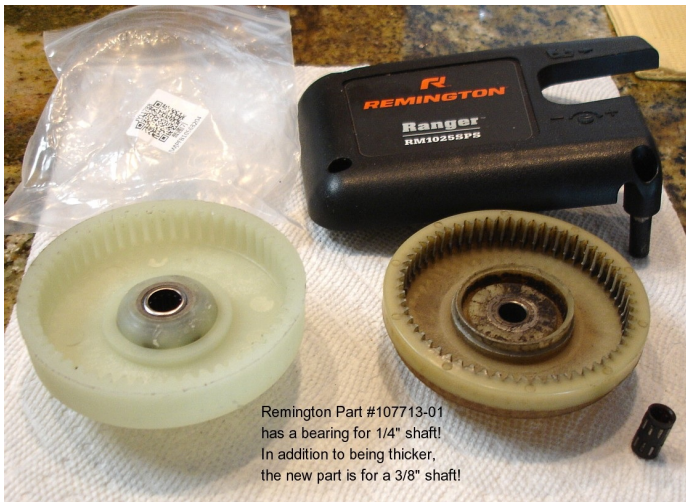
Before continuing, let us take a moment to address the sprocket. A replacement can be purchased on line. HOWEVER, do NOT purchase the replacement shown from China, as tempting as the price may be. While it is listed as a direct replacement for the RM1025SPS chainsaw, part number #107713-01, it is not! It is considerably thicker, has 6 teeth on the center gear instead of the required 5 teeth, and has a 3/8" shaft opening instead of our 1/4" shaft. See the next picture.

Order a new #107713-01 sprocket, if needed, from a US source, such as from the listing "Indiana 717-04749 5 tooth MTD sprocket RM1025..." on Ebay, where I ordered mine. This was a perfect fit.

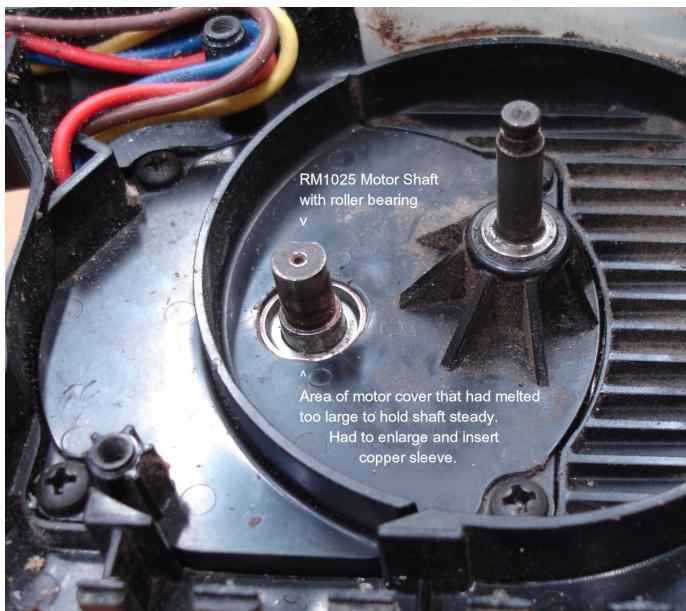
Ok. Back to our issue at hand. Unless the sprocket failed on its own and just needs replacement, you will find the motor shaft is no longer held firmly by this plastic bracket or plate. Hopefully, however, it is only damaged slightly and there is sufficient good plastic material that you can still repair the saw by creating a sleeve that just fits the outside dimension of the motor shaft bearing ($\frac{1}{2}$ ") and will fit the size of the new hole that you must create in the bracket. A $\frac{3}{8}$ " piece of $\frac{1}{2}$ " rigid copper pipe works perfectly.

Locate a piece of $\frac{1}{2}$ " rigid copper pipe, but do not cut off a piece yet. It will be easier to work with the larger piece of pipe first. Square off and remove any burrs from one end of your pipe. Sand inside and out until it fits over the bearing on the end of the motor shaft. It should be snug, but do not use pressure to press it on. This bearing is fragile and can be easily damaged from too much force.

Next, you must locate the center of the original hole in the bracket. You cannot simply drill out a new hole because the hole has now been elongated into an oval toward the sprocket axle. We must carefully expand the opening such that the new hole center is in the exact same location as the original.

Carefully ream or file out the desired diameter of the new hole, testing the fit with the pipe end as you go. We want a snug fit with the pipe end.

Once you are satisfied with the fit over the bearing and in the bracket, cut off the desired length of pipe needed - about $\frac{3}{8}$ " to create our sleeve. I found that the usual rotary copper pipe cutter (one is pictured above) works well. The new cut end will have a bit of a tapered lip, but this just makes it easier to insert into our new hole in the plastic bracket.
