A Professional Journal Exclusively for the Heath/Zenith Z-100 Computer

HOWGOZIT	1
EasyPC Woes	1
GEMINI Woes	3
ZCLK PC-DOS Software Patch	4
SmartWatch Battery Mod Update	5
<u>New</u> ZCLK2 Calendar/Clock Package	Insert
Z-100 Price Sheet for 2018	Insert

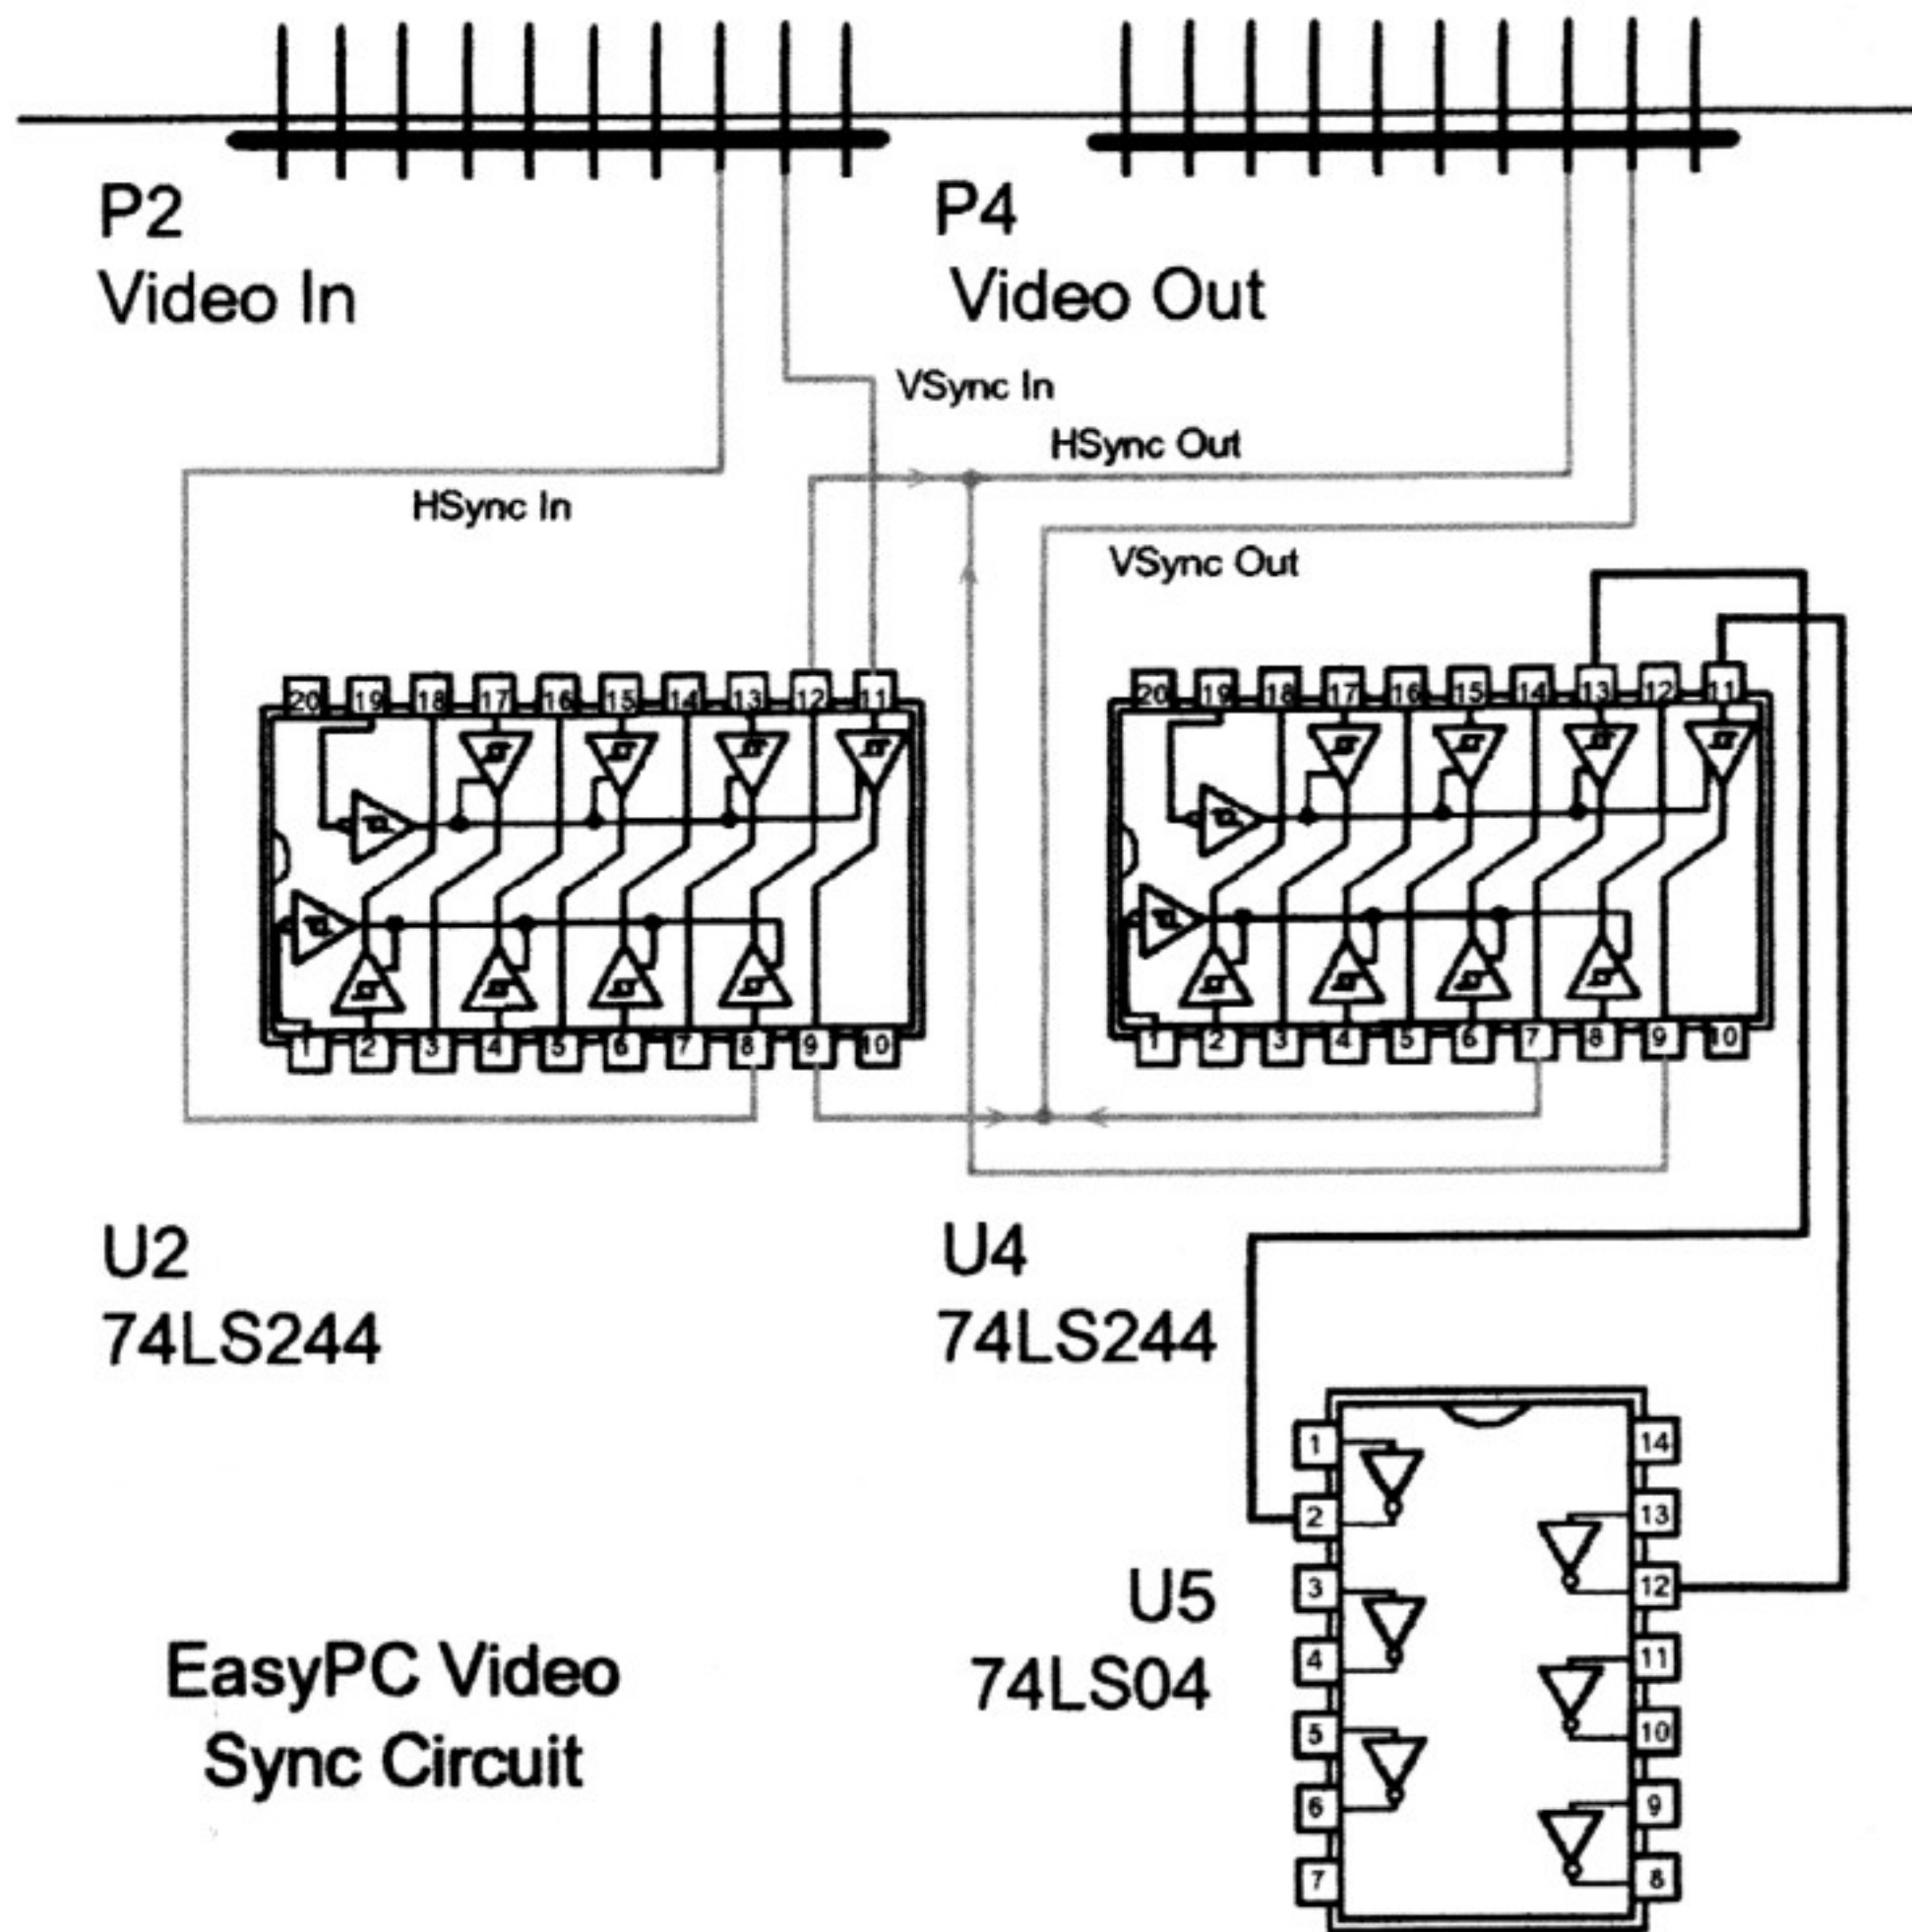
The other two main boards seems to be fine, but the three video boards had issues. Two had an issue with sending video to my color C.Itoh monitor. The characters were slanted and/or torn, and unreadable in both native and IBM modes. Yet the display was fine on a Zenith ZVM-135 color monitor!

From the above you can see that the video in Zenith mode goes from connector P2 (IN) to connector P4 (OUT) via U2, a 74LS244 that acts as a switch. The same is true of PC video generated by the EasyPC video board, which goes through U4, another 74LS244 chip.

When pins 1 and 19 are low, or turned on, data is passed from that respective 74LS244 chip to the output connector P4. When one 74LS244 is turned on, the other is turned off (set high).

Checking the state of pins 1 and 19 of each 74LS244 chip in Zenith and in PC mode confirmed that the chips were indeed working fine. Rather than removing these chips using heat, I ground off the body of the chips from the pins, then removed each pin with a soldering gun. I replaced the chips with sockets, then placed new 74LS244 chips in the sockets.

Back in operation, the symptoms were the same as before. Before I panicked, I tried different 244 chips. Yep, depending upon manufacturer and chip type, the symptoms got better or worse. I got the best results with 74HCT244 chips in U2, and as I only had two of those, I placed 74ALS244 chips in U4. I video was now perfect on all monitors.

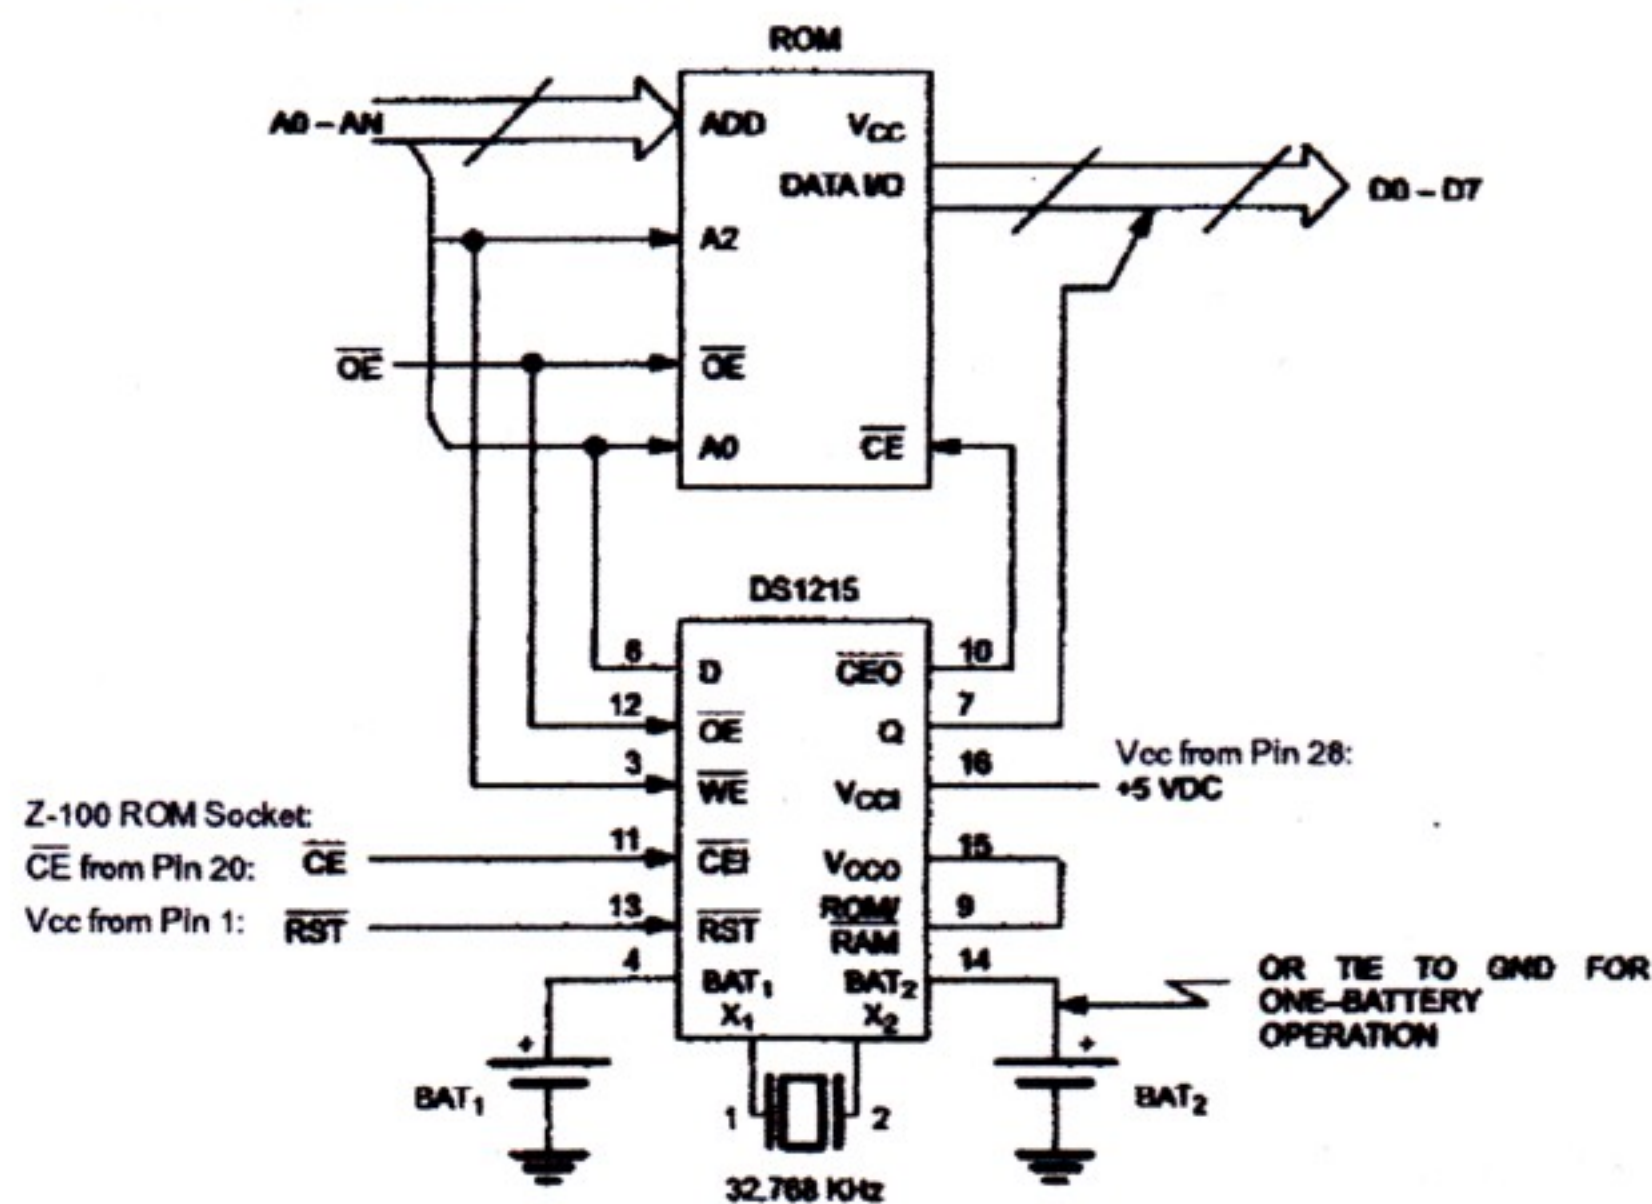
ROM/TIME CHIP INTERFACE Figure 4

The DS1216E SmartWatch module uses the DS1215 clock chip on a circuit board that is installed under the Monitor ROM at U190 on the motherboard in the Z-100. All the pins are connected directly from the ROM IC through the SmartWatch module to the Z-100 socket at U190, except Pin 20. Pin 20 is the Chip Enable (CE) line.

In simple terms, the SmartWatch module intercepts any Chip Enable (CE) signal from the Z-100, reads the data to see if the clock is needed or if the data is meant for the ROM chip, then issues its own Chip Enable (CE) signal to the ROM if the clock was not being addressed.

It appears that this communication was not happening in my SmartWatch, in spite of the fresh battery.

Looking at the circuitry above, my resistance reading all checked out except at Pin 14 of the DS1215 chip. The note for Pin 14 reads "or tie to gnd for one-battery operation". Well, on my SmartWatch, Pin 14 was NOT tied to ground. Apparently, there was a second battery (also dead) installed in this SmartWatch module.

Again studying the circuitry, if I just tied Pin 14 to ground, that would also disconnect the second battery from any possibility of charging current (grounded at both ends), so I soldered another wire from Pin 14 to Pin 8 (ground) on the DS1215 SmartWatch.

The SmartWatch now allowed me to power up and the clock was now operational. I hope you find this helpful.
