Remington RM1025SPS Chainsaw Repair

This article will focus on disassembly, repair, and reassembly. The repair will address the mechanical failure of the chain drive.

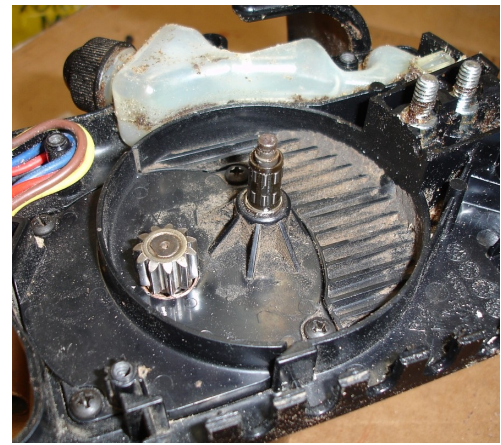
7. The large drive gear is positioned on the motor shaft. It should be held tightly in position by the plastic bracket or plate as shown in the above picture. It is held in position by four screws at the four corners. Lift off this large gear for a better look at the bracket.

I am sorry that I don't have a picture of my melted bracket, but on my saw, the motor shaft was no longer held in position because the hole had been enlarged from an overheated motor shaft that became so hot as to melt the soft plastic that surrounded the motor bearing. This allowed the large gear to move towards the sprocket axle enough to disengage the teeth of the sprocket and grind down the teeth as shown in the next photo. If left unchecked, the teeth would eventually disappear, rendering the saw useless!

Ok. Back to our issue at hand. Unless the sprocket failed on its own and just needs replacement, you will find the motor shaft is no longer held firmly by this plastic bracket or plate. Hopefully, however, it is only damaged slightly and there is sufficient good plastic material that you can still repair the saw by creating a sleeve that just fits the outside dimension of the motor shaft bearing ($\frac{1}{2}$ ") and will fit the size of the new hole that you must create in the bracket. A $\frac{3}{8}$ " piece of $\frac{1}{2}$ " rigid copper pipe works perfectly.
